# ANCHOR GUARD LLC

## Infrared Electrical Inspection Report

AG-2026-0142

| Site | Ridgeway Commerce Center, 4200 US-1 S, St. Augustine, FL | Report date | July 6, 2026 |

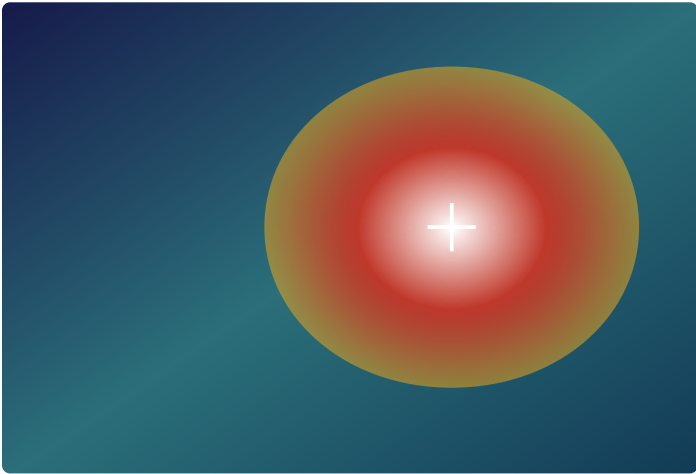
FINDING 1

| # | LOCATION | COMPONENT | ΔT | SEVERITY | RECOMMENDED ACTION |
|---|---|---|---|---|---|
| 1 | Electrical Room 101 — MDP-1 | Main distribution — B-phase lug | 56°C / 100°F | CRITICAL | Repair immediately — potential failure / fire risk |

| Location | Electrical Room 101 — MDP-1 | Component | Main distribution — B-phase lug |

Thermal image (sample)

Visible-light reference photo

| 32°C / 90°F | 88°C / 190°F | 56°C / 100°F | 0.95 |

**Observation:** Severe localized heating at the B-phase main lug termination; adjacent A and C phases normal.

**Probable cause:** Loose or corroded lug connection creating high-resistance joint under load.

**Recommended action:** De-energize and repair immediately. High risk of connection failure and arc/fire. Have a licensed electrician re-terminate and torque to spec, then re-scan.

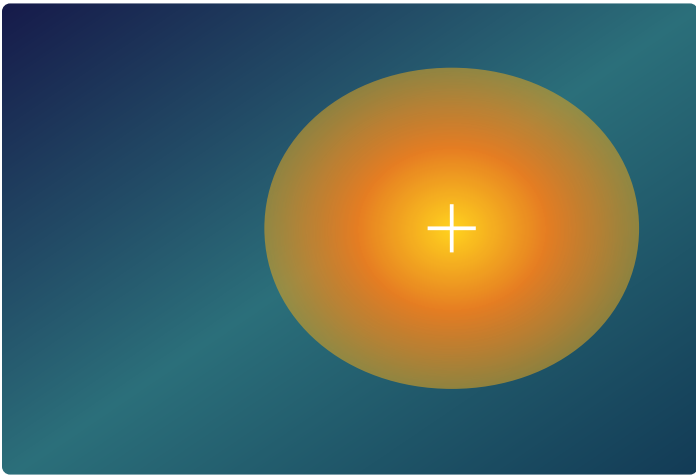
FINDING 2

| # | LOCATION | COMPONENT | ΔT | SEVERITY | RECOMMENDED ACTION |
|---|---|---|---|---|---|
| 2 | Suite 120 — Lighting Panel LP-2 | Breaker #14 | 24°C / 43°F | SERIOUS | Repair as soon as possible; monitor closely |

| Location | Suite 120 — Lighting Panel LP-2 | Component | Breaker #14 |

Thermal image (sample)

Visible reference

| REFERENCE<br>30°C / 86°F | MAX MEASURED<br>54°C / 129°F | ΔT (RISE)<br>24°C / 43°F | EMISSIONITY<br>0.95 |

**Observation:** Elevated temperature at breaker #14 relative to neighboring breakers at similar load.

**Probable cause:** Loose breaker-to-bus connection or an overloaded circuit.

**Recommended action:** Repair as soon as possible. Verify circuit load, re-seat/replace breaker as needed.

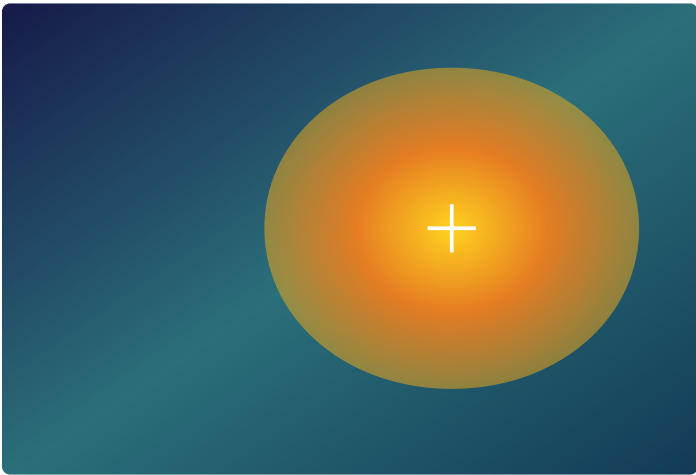
FINDING 3

| # | LOCATION | COMPONENT | ΔT | SEVERITY | RECOMMENDED ACTION |
|---|---|---|---|---|---|
| 3 | Rooftop — RTU-3 disconnect | Line-side contactor | 13°C / 23°F | INTERMEDIATE | Repair as schedule permits |

| Location | Rooftop — RTU-3 disconnect | Component | Line-side contactor |

Thermal image (sample)

Visible reference

| REFERENCE<br>34°C / 93°F | MAX MEASURED<br>47°C / 117°F | ΔT (RISE)<br>13°C / 23°F | EMISSIONITY<br>0.95 |

**Observation:** Moderate heating at the line-side contactor of the rooftop unit disconnect.

**Probable cause:** Contactor contact wear / early degradation.

**Recommended action:** Schedule contactor inspection/replacement at next preventive-maintenance cycle.

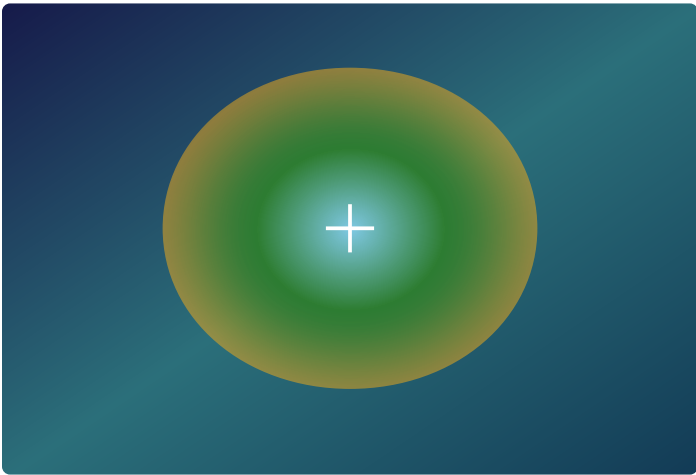
FINDING 4

| # | LOCATION | COMPONENT | ΔT | SEVERITY | RECOMMENDED ACTION |
|---|---|---|---|---|---|
| 4 | Electrical Room 101 — DP-4 | All phases | 2°C / 4°F | MINOR | Investigate / monitor at next PM |

| Location | Electrical Room 101 — DP-4 | Component | All phases |

Thermal image (sample)

Visible-light reference photo

| 31°C / 88°F | 33°C / 91°F | ΔT (RISE)<br>2°C / 4°F | 0.95 |

**Observation:** Balanced, uniform temperatures across all phases; no anomaly.

**Probable cause:** Normal operating condition.

**Recommended action:** No action required. Included to document panel was surveyed and found normal.
